CARR-1293

HISTORIC PRESERVATION CERTIFICATION  
APPLICATION—PART 1

Name of property: (Unofficial): "Babylon", "Albaugh-Babylon" or "Albaugh-Babylon Grocery Co." Bldg.

Address of property: 10 East Main Street

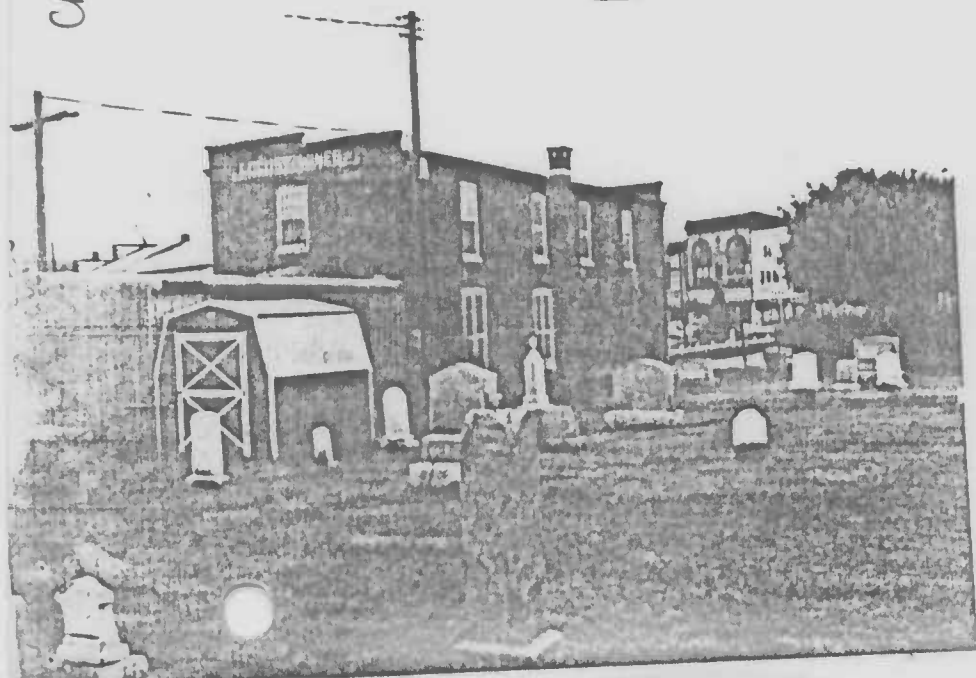
No. III. This shot is similar to No. II except the County Library on the east side of the passage is better lighted. (The Baltimore Federal Building is not shown here.)

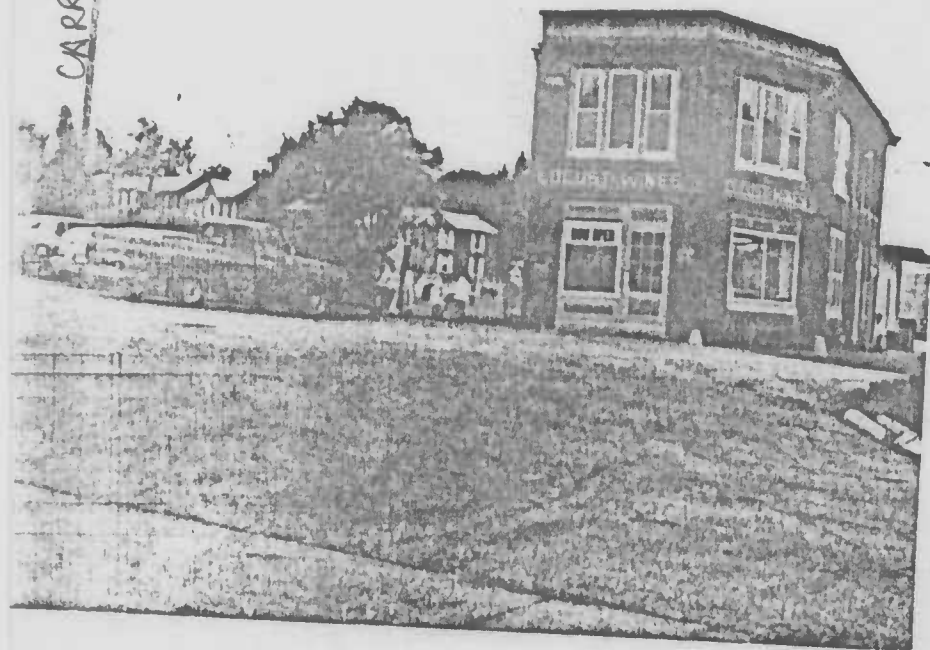
No. V. This shows the western exposure more fully, and the back of the library to the left.
